# *Burnt Clay Products in Fire and Earthquake*

*Issued by the Manufacturers of Burnt Clay Products*  
***Brick Construction Association***  
*707 Lankershim Building, Los Angeles, Cal.*

## *The San Francisco Calamity*

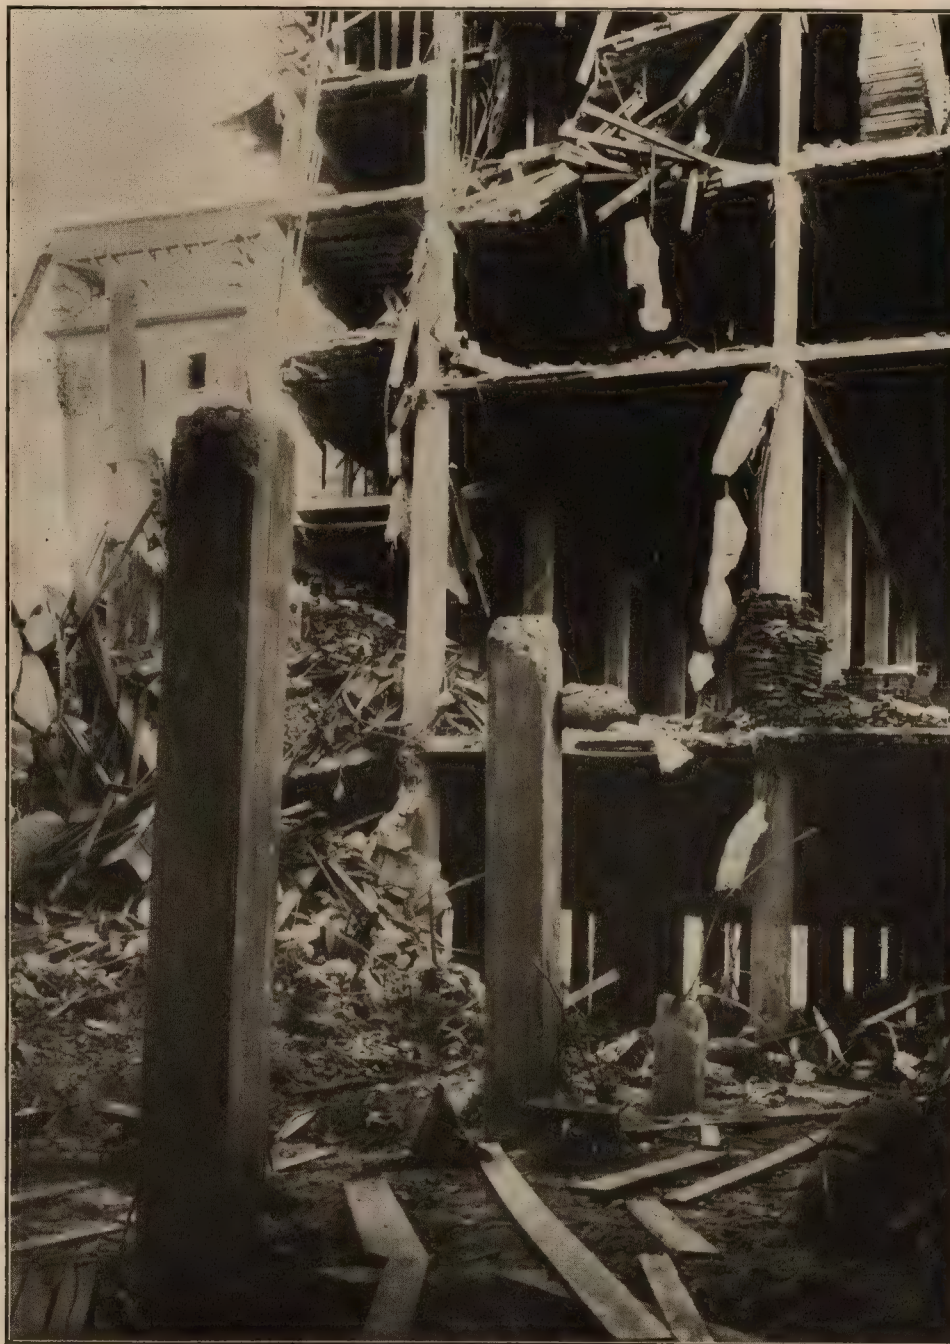
The two stumps of columns in background are supposed to have been the ones which caused the disaster. They crushed under the imposed load.

required in this particular building, the accompanying photograph will show from the cone-shaped appearance of columns at the point of breaking, that the failure was caused by spalling or crumbling. The reinforcements of such columns were buckled outwardly from the center, proving conclusively that columns were crushed from the imposed load, and as the columns crushed and came down, it being monolithic construction, the floors, columns and girders above followed them down.

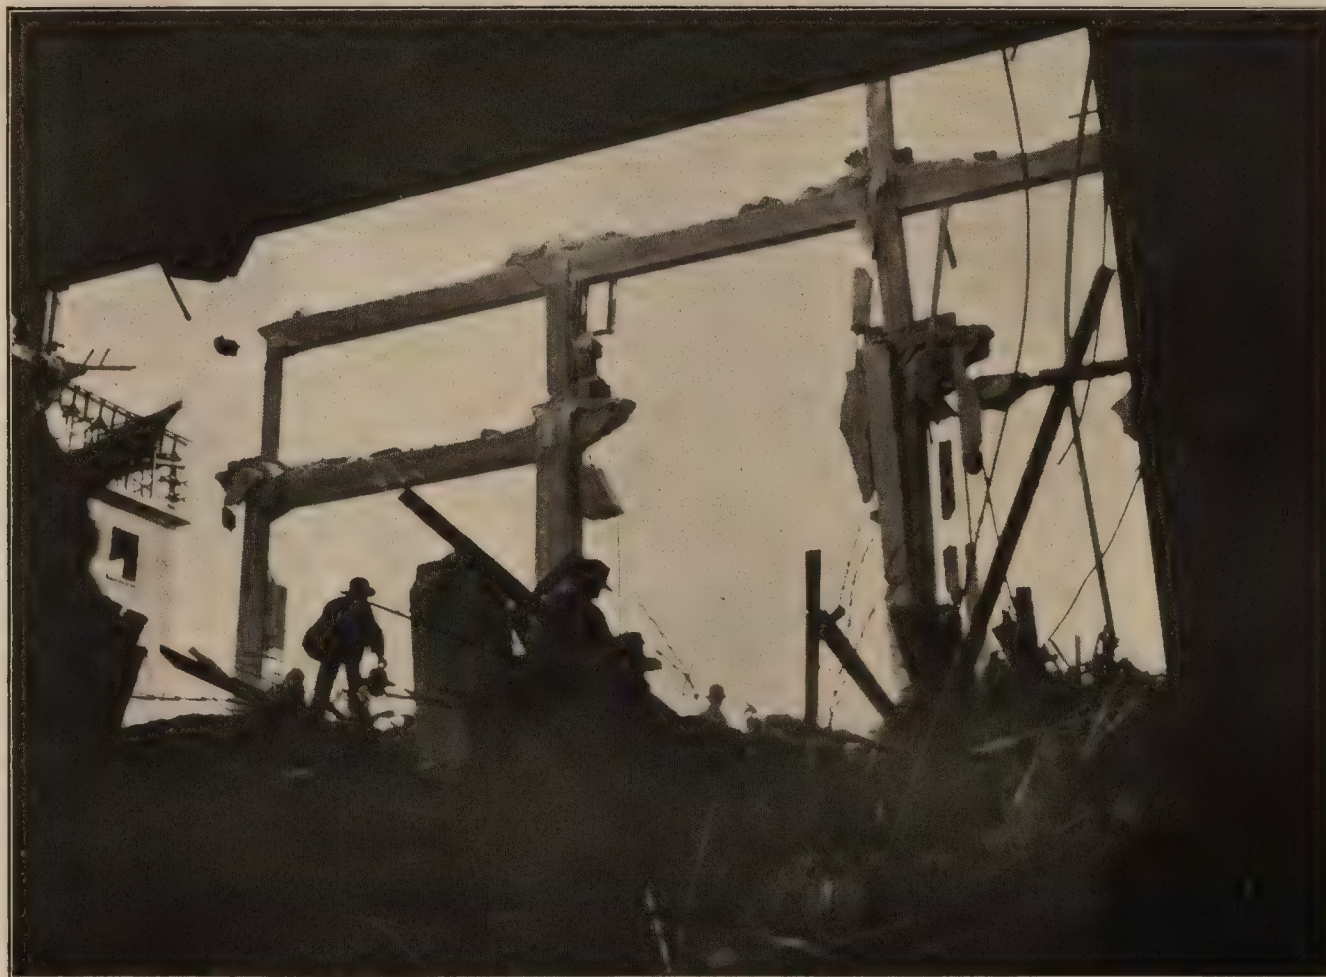
*Bixby Hotel, Long Beach, Cal.*

Searching for the dead and wounded.

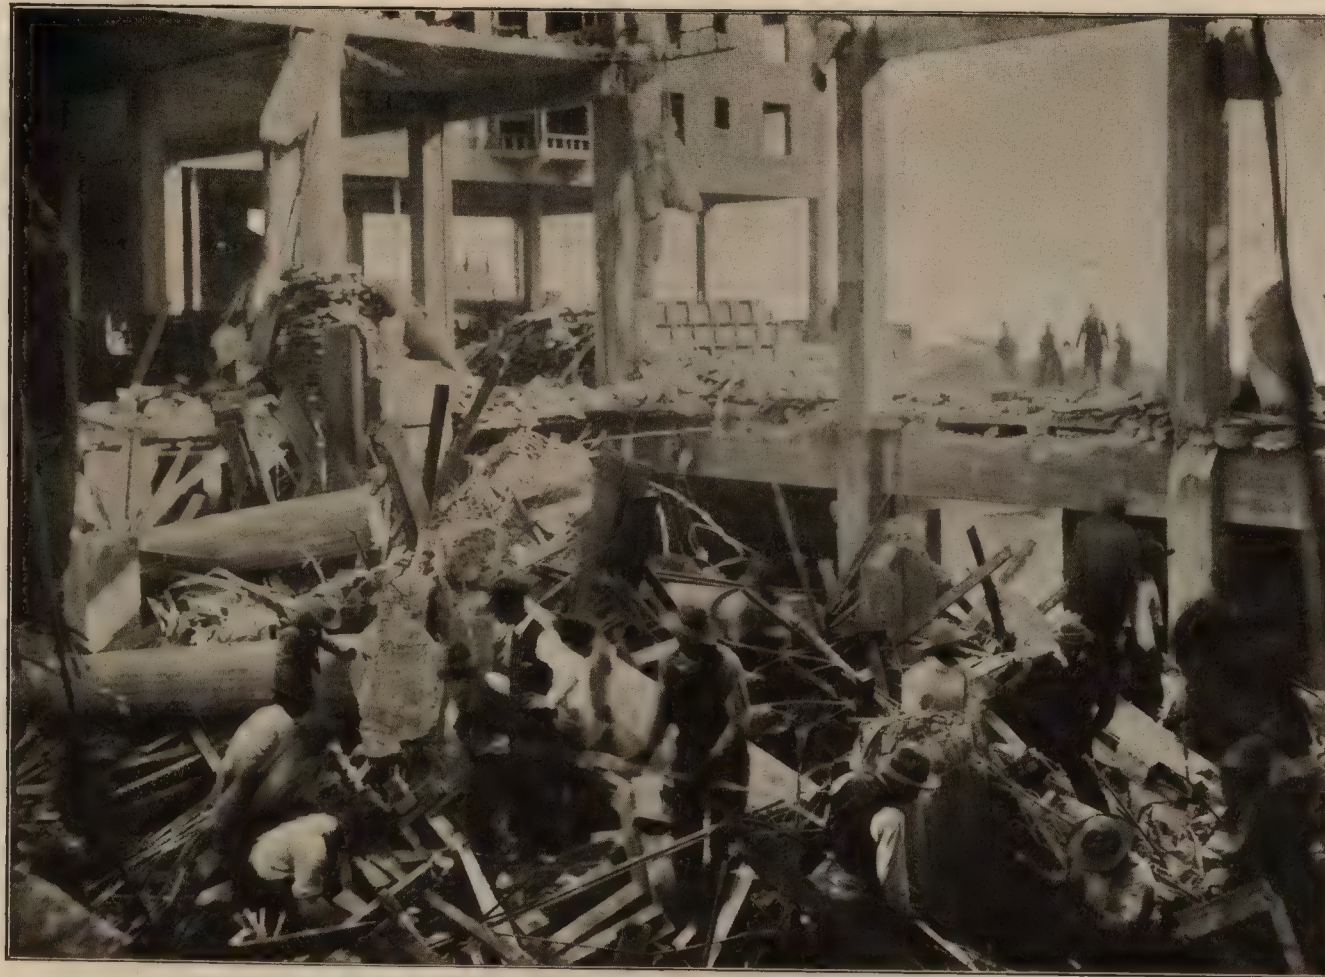
*Bixby Hotel, Long Beach, Cal.*

Built of reinforced concrete.

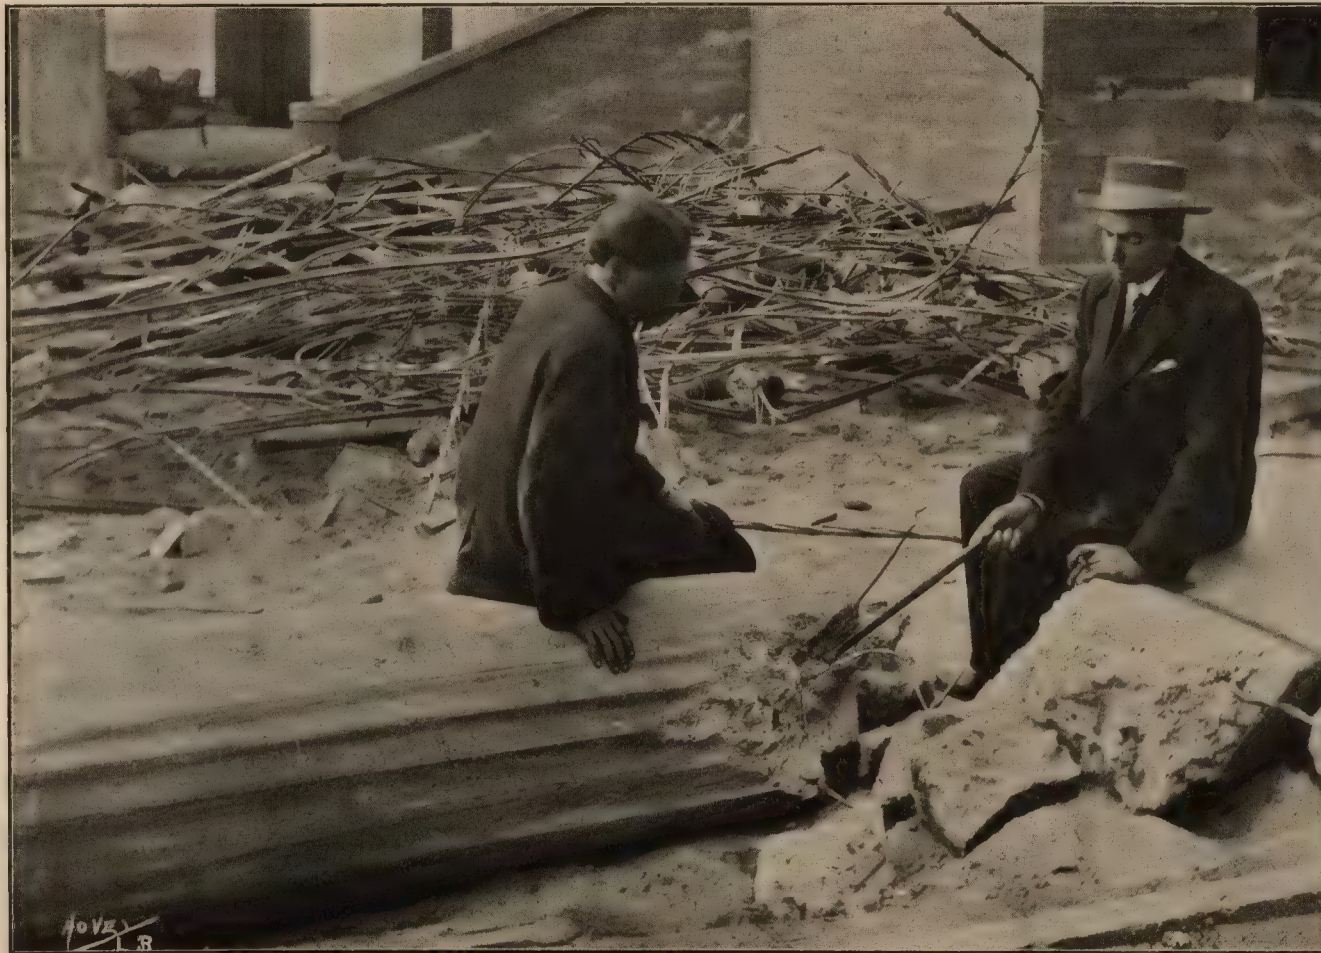
*Bixby Hotel, Long Beach, Cal.*

Showing the point of failure in reinforced concrete column.  
Note pile of reinforcements.

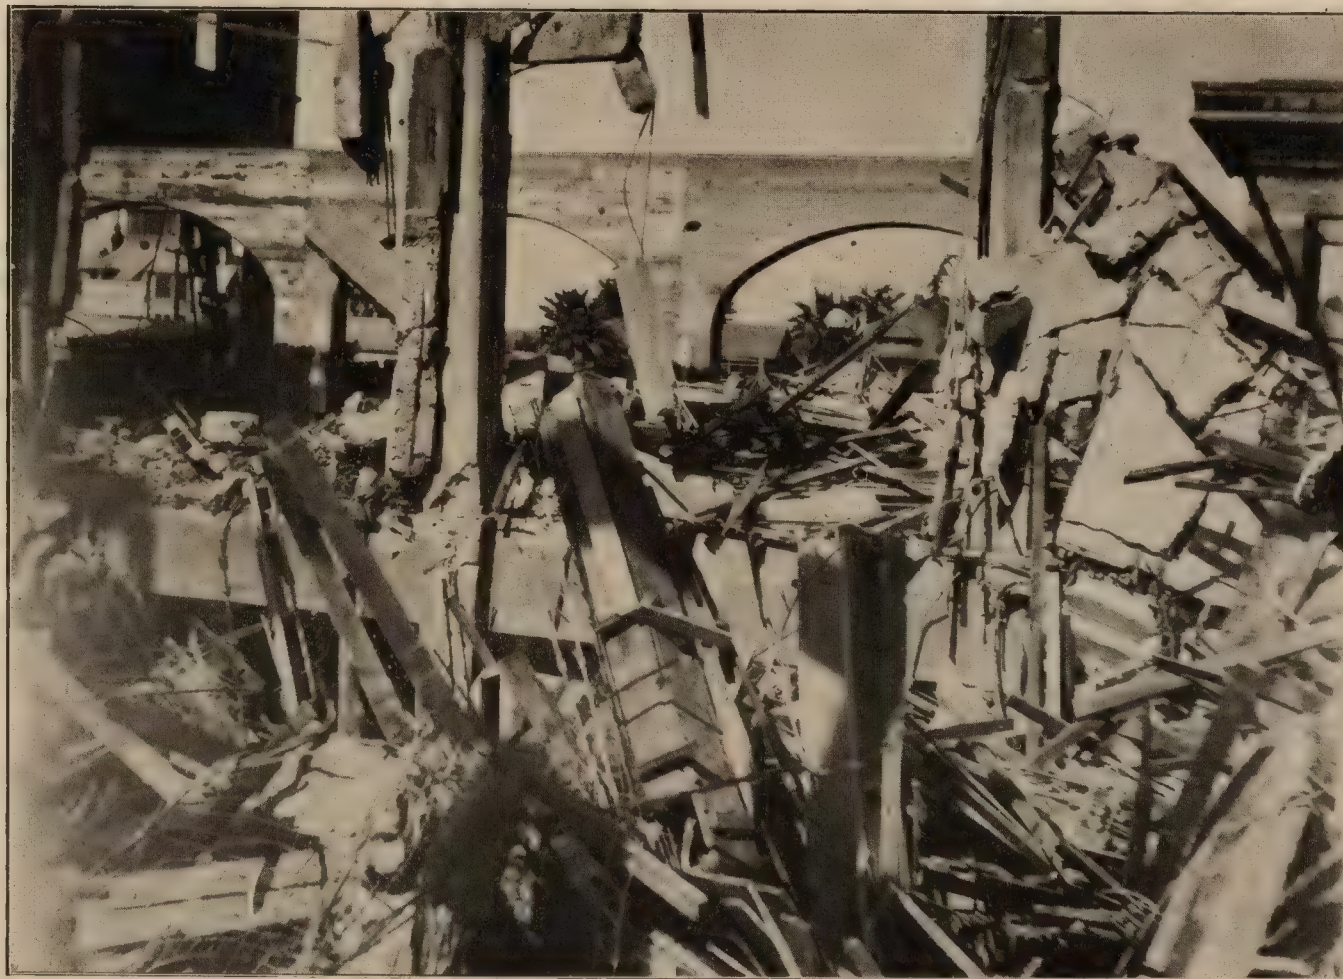
*Bixby Hotel, Long Beach, Cal.*

Two hours after the collapse, showing the manner in which the debris was piled up.

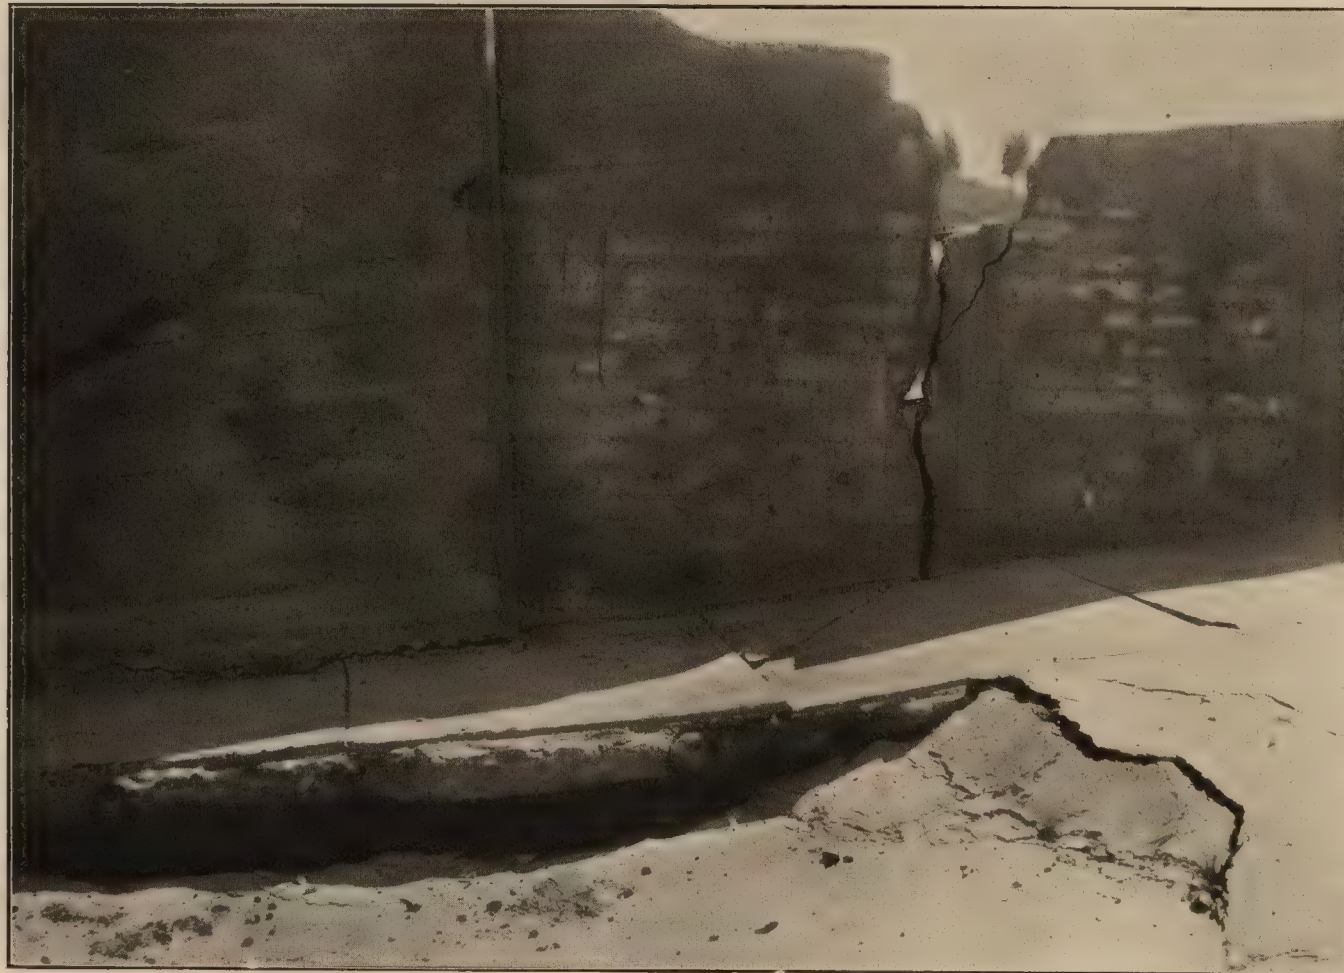
*Reinforced Concrete Bridge*

Showing failure of side wall and roadway.

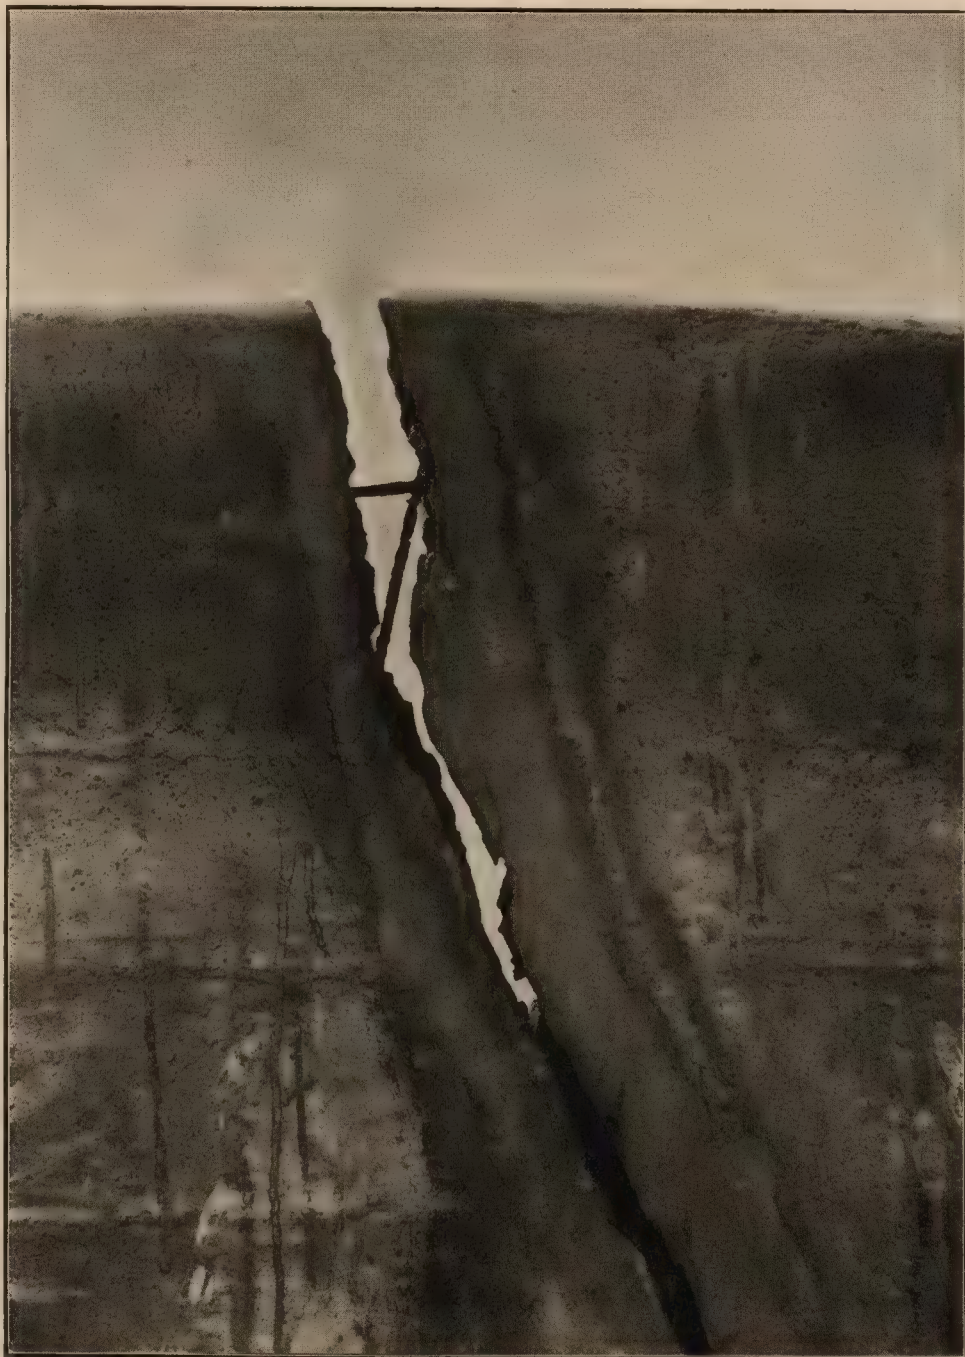
### *Reinforced Concrete Bridge*

Side wall showing reinforcements. An attempt was made to patch the cracks (note lines on cement) when they first appeared, but failure in concrete cannot be successfully patched, as picture shows.

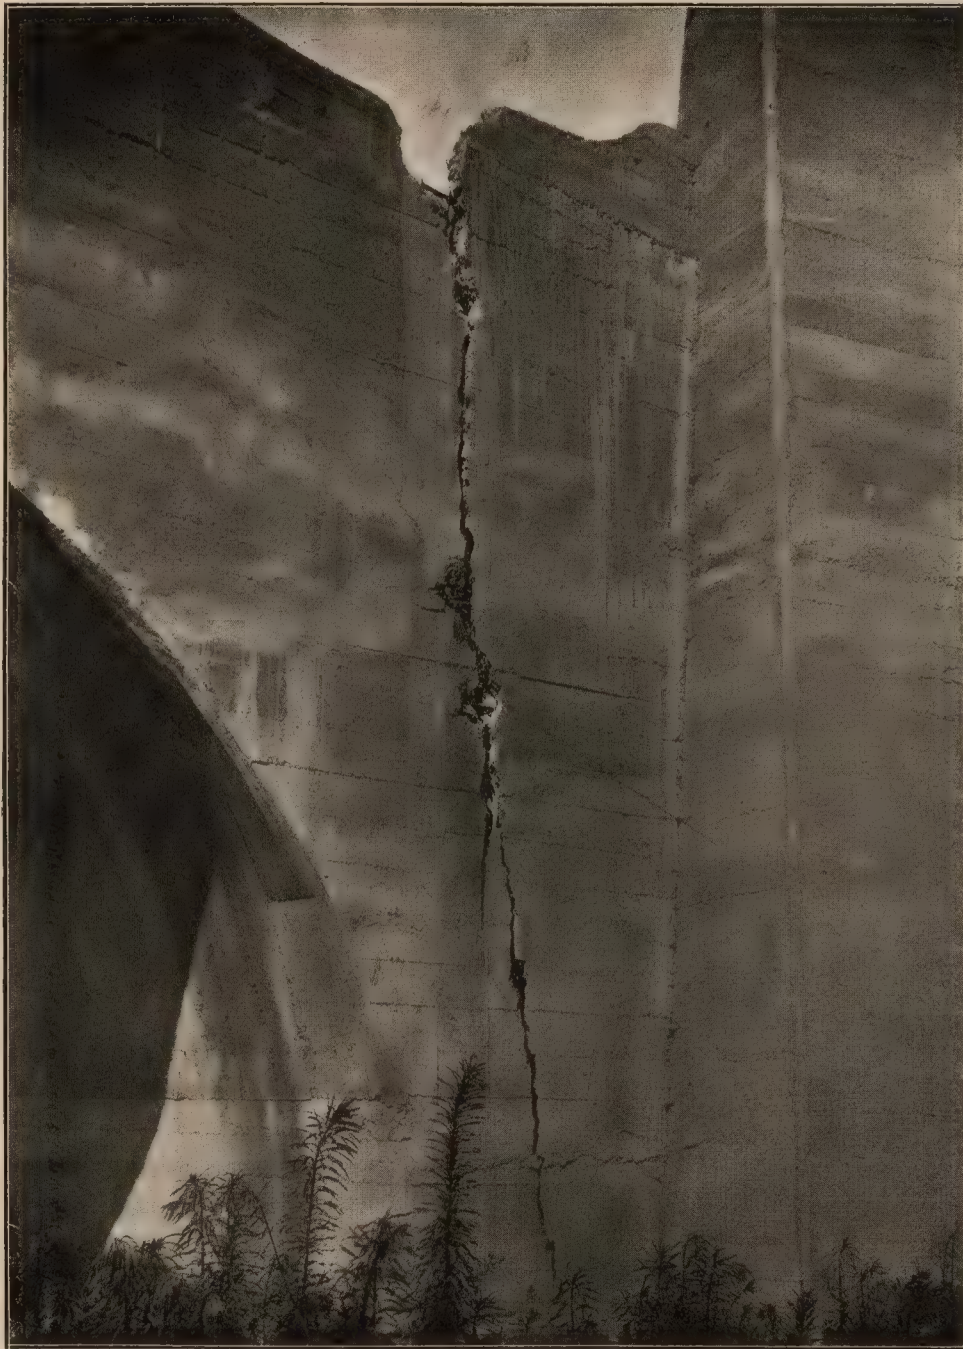
*Reinforced Concrete Bridge*

Vertical crack in abutment. This same crack also appears on the other side of bridge.

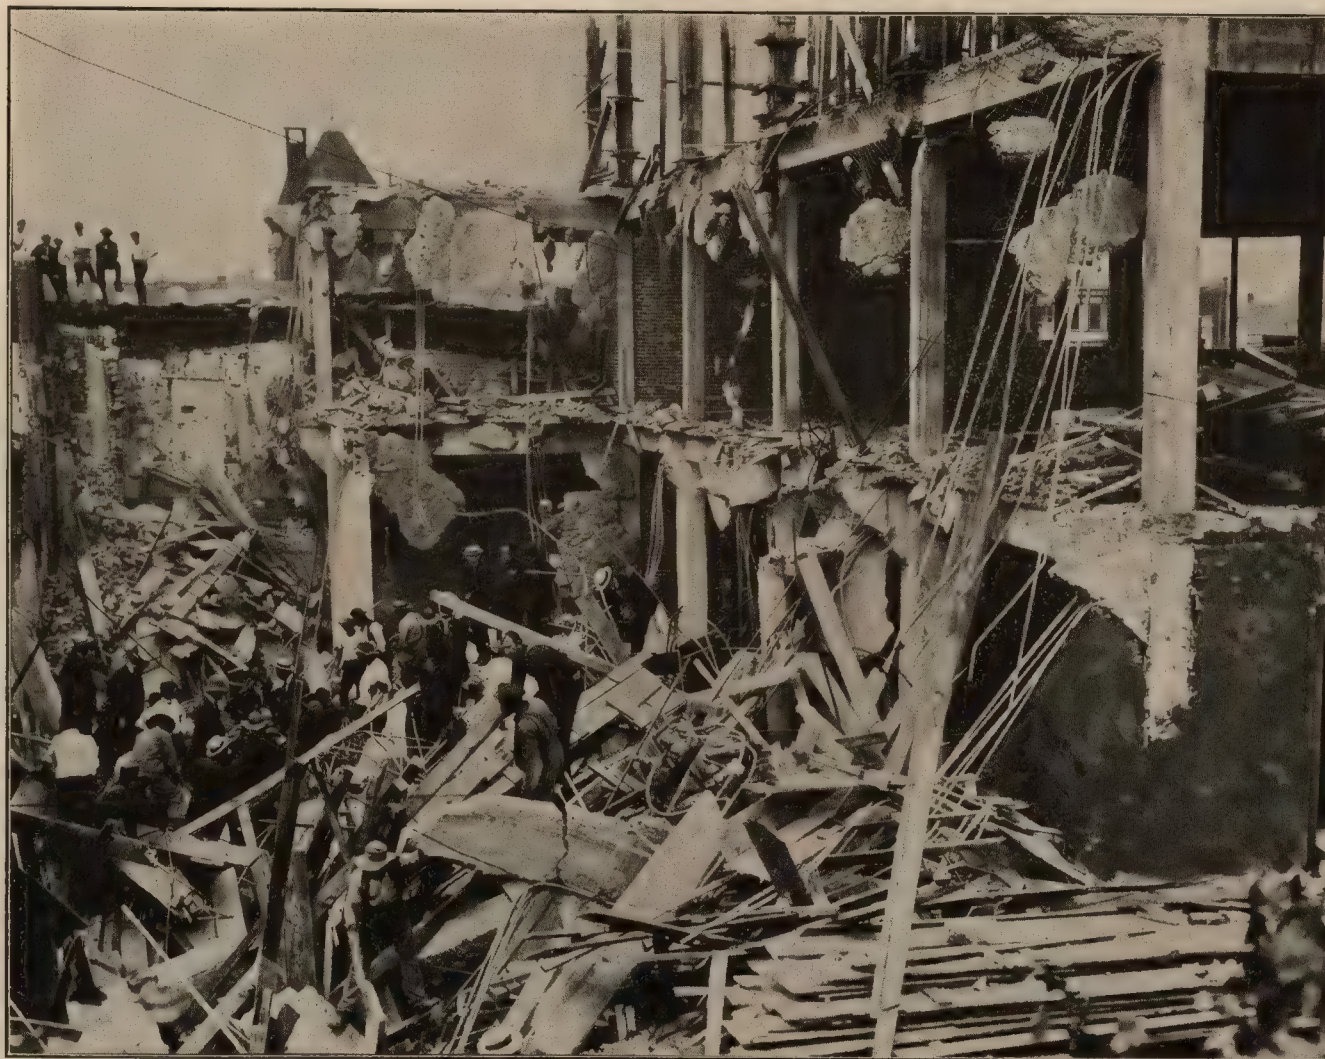
*Bridgeman Bros. Building, Philadelphia, Pa.*

Reinforced concrete. Searching for dead and wounded. Collapsed Wednesday,  
July 10, 1907. Four men were killed and twenty injured.

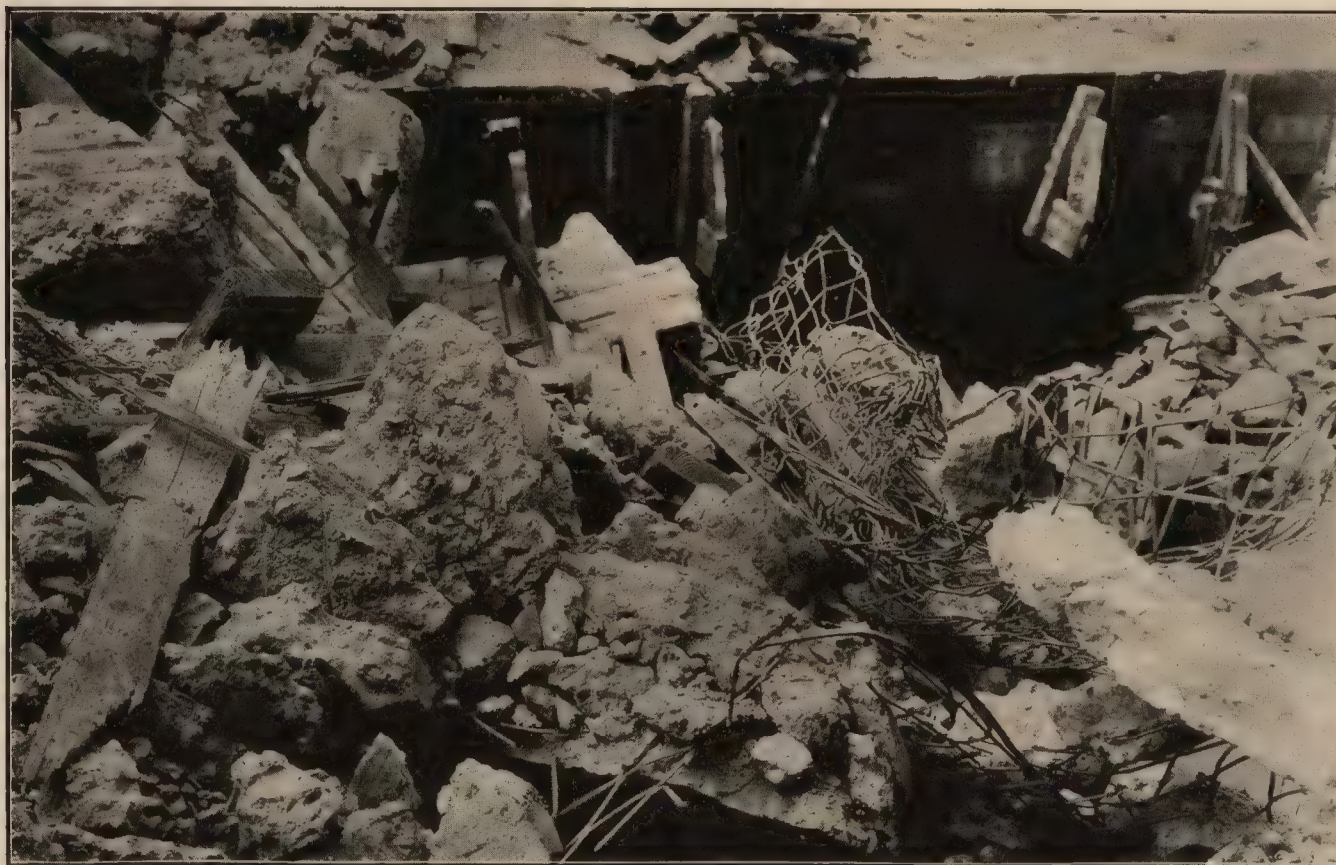
*Bridgeman Brothers Building*

Mass of fallen concrete.

### *Says Work Was Defective.*

John Clark, of 1218 Cabot street, superintendent of cement finishers, who was at work on the second floor when the crash came, stated it as his belief that the accident was caused by defective concrete work on the fourth or top floor of the building. He said: "The concrete of the fourth floor was put into place two weeks ago, and the concrete itself was of sufficiently good material, but was not treated properly after it was put into place.

"For concrete to become properly 'set' it should be thoroughly wetted every morning for at least four days. I am not aware that the concrete on that top floor was wetted after it was put in except by the rain, which was insufficient. Its exposure to the sun, too, caused it to dry out with extra quickness. The effect of this premature drying caused the concrete to shrink from the supporting rods; it didn't have the proper 'grip,' and the consequence was that when the supports were knocked away this morning the floor collapsed of its own weight."
